Investigation of Road Systems in Engineering-geological Condition of Kazakhstan

Abstract. The purpose of the work is to present the results of the overpass structural survey and to determine the causes of the structural defects. Especially it is urgent task for countries with big and vast territory such as Kazakhstan. The territory is located in center of Eurasia, where are intersected many international ways between Europe and Asian countries from Ancient times to nowadays. One of the main international highway road is Yekaterinburg – Almaty (2336 km) which is one of main transportation road between Russia and Kazakhstan. Reconstruction of this road was done intensively in 2013. There is overpass construction which is constructed on section 1114-1137 km of Yekaterinburg – Almaty road. Unfortunately, deformation of bearing structures of overpass are detected during construction process. Therefore, it is proposed observation of deformed structures, soil ground. Before continuing construction process. The overpass is located in Zhaltyr village of Akmola region.

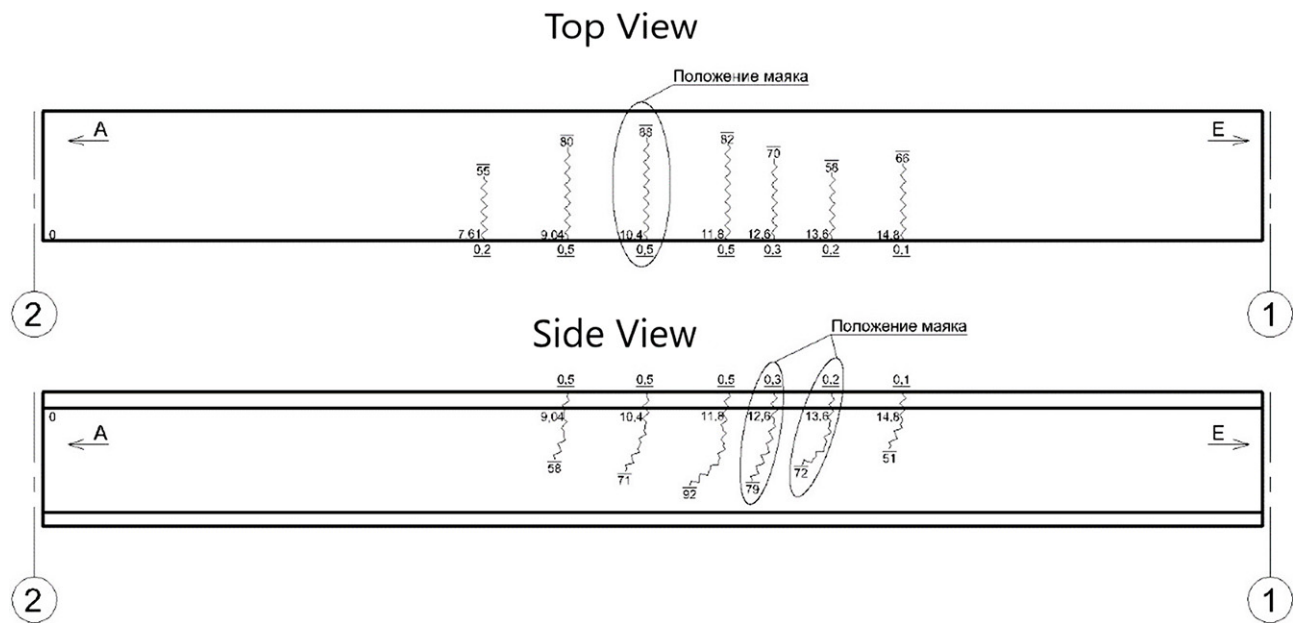
Figures 3-6 presented defecting by cracks of the beams, underbeam concrete slabs and defects of concrete slabs.

During the inspection of reinforced concrete beams of the span of the overpass, measures were taken to monitor the crack opening. Specialists of the laboratory of KGS LLP installed marks in the upper part of the shelf of the beams of the superstructure, as well as in the transition of the shelf to the wall from the inside of the beams. The position and width of the cracks were also recorded. The results of observation of crack opening during the monitoring period are

Figure 3 – Defecting by cracks of the beams (top and side view)

Monitoring showed that the development of cracks does not occur, since the beams are in the design position and are not loaded.

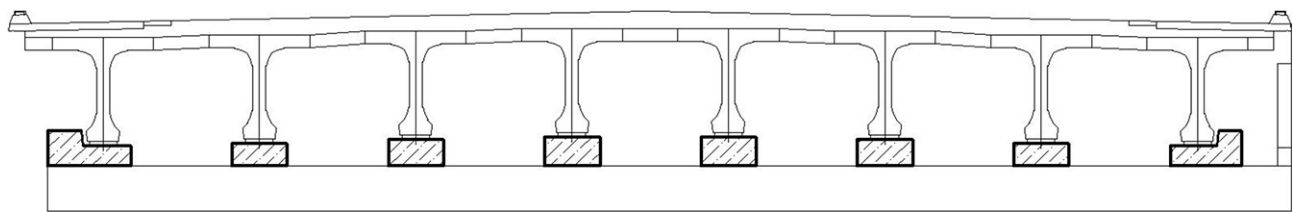
The arrangement and marking of the sub-enzyme concrete slabs is shown in Figure 7. The main defects of the sub-enzyme concrete slabs are cracks with an opening width of up to 3 mm, spalls up to 30 mm

deep caused by low concrete strength (class B5-B10).

Figure 4 – Underbeam concrete slabs

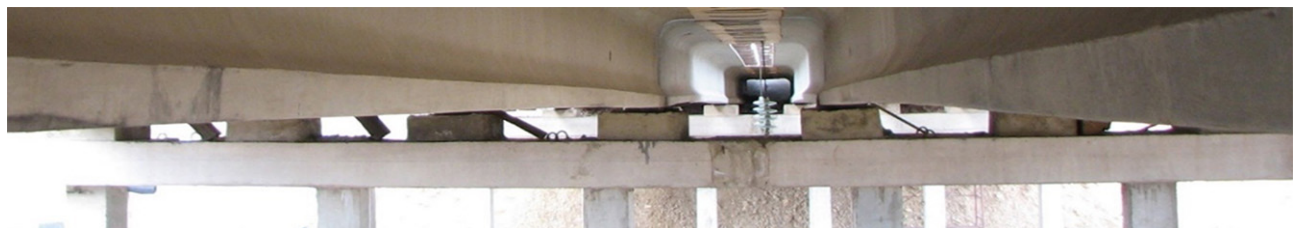
Figure 5 – General view underbeam concrete slabs

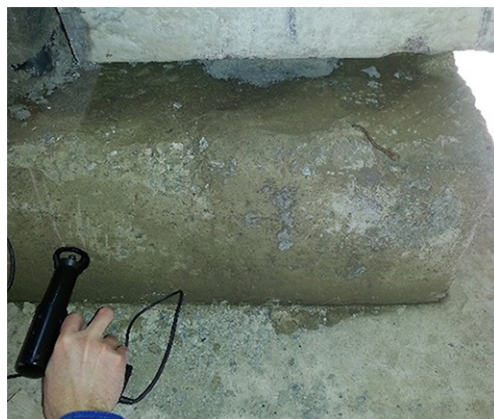
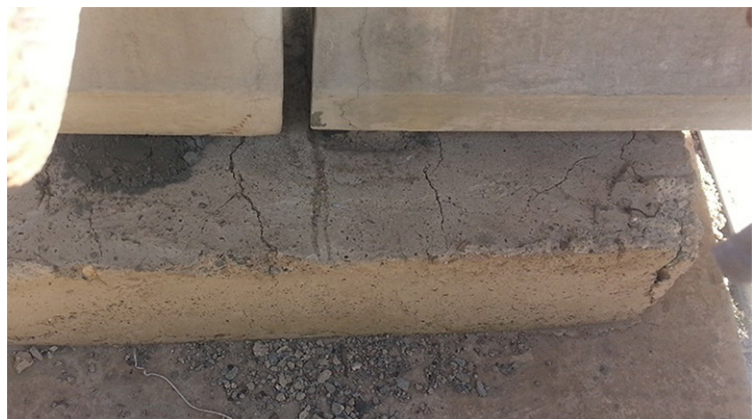
Figure 6 – Defects of concrete slabs

- underbeam concrete slabs – category IV (pre-emergency state of construction), the results of determining the strength of concrete stones showed that all underbeam concrete slabs did not gain design strength (B25), especially low-strength concrete (B5) has truss stones along axes 2 and 3 (middle supports). The cause of defects is basically improper care of the concrete and possible freezing of the concrete during hydration.

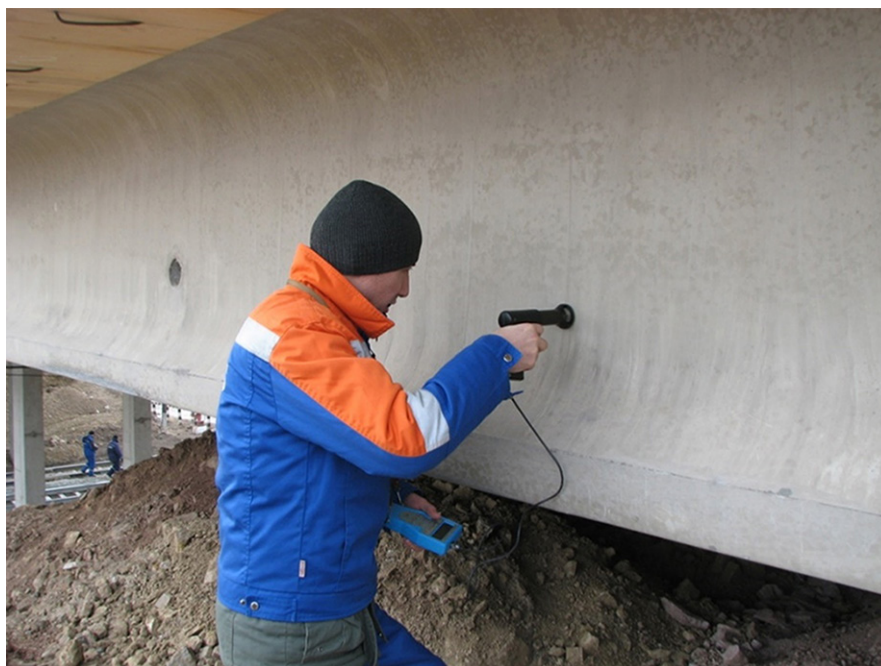
According to the results of studies of concrete beams given in table 1, it was revealed that there are no deviations from the project.

The control points for measuring the strength of concrete were located on the side faces of the walls and flanges of reinforced concrete beams of the span (see Figure 7). The strength of concrete was determined at several points along the length of the beam (see Figure 8).

Figure 7 – Span beam concrete strength test

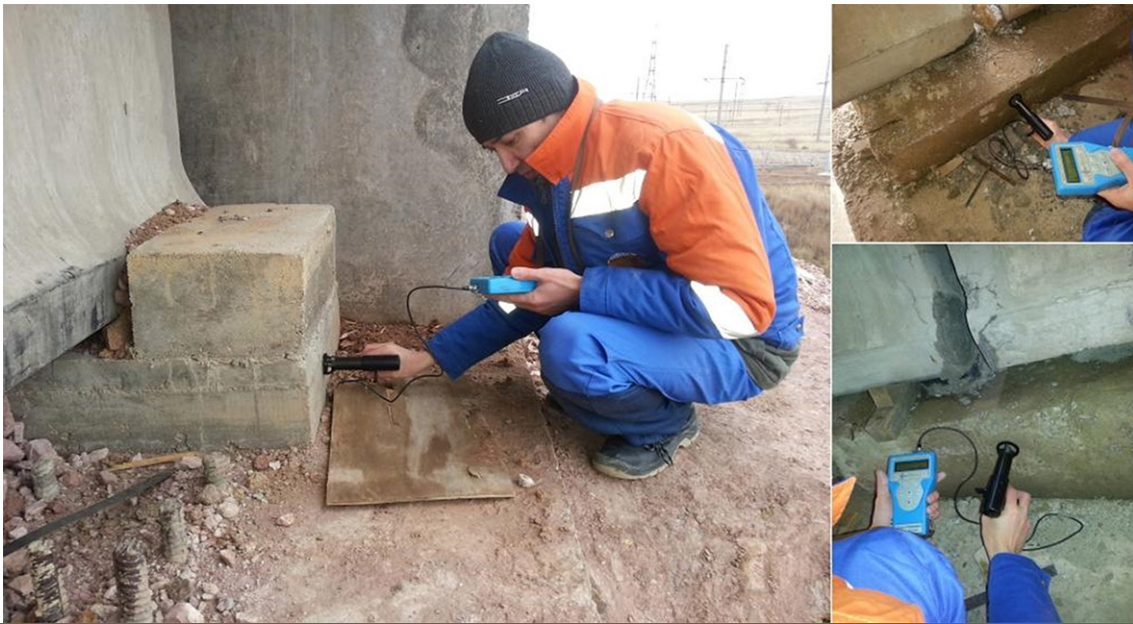
According to the results of studies of the concrete strength of monolithic sub-truss stones given in table 3, it was revealed that there are deviations from the design data.

Figure 8 – Strength test of underbeam concrete slabs
