# Methods for Recovery of Keyways of Electric Motor Shaft

**Abstract.** The aim of the study is to develop a technology for the restoration of keyways in electric motor shafts. The statistics of the restored parts of the type of bodies of revolution at the repair enterprises of the Karaganda region are presented. Defects of keyways of electric motor shafts are given. Methods for restoration of keyway slots are described, as well as the features of these restoration methods. The traditional and proposed technologies for the restoration of keyways are presented. Optimal modes of surfacing during restoration of keyway slots are given. The values of hardness in the deposited layer and in the fusion zone of the keyway have been determined.

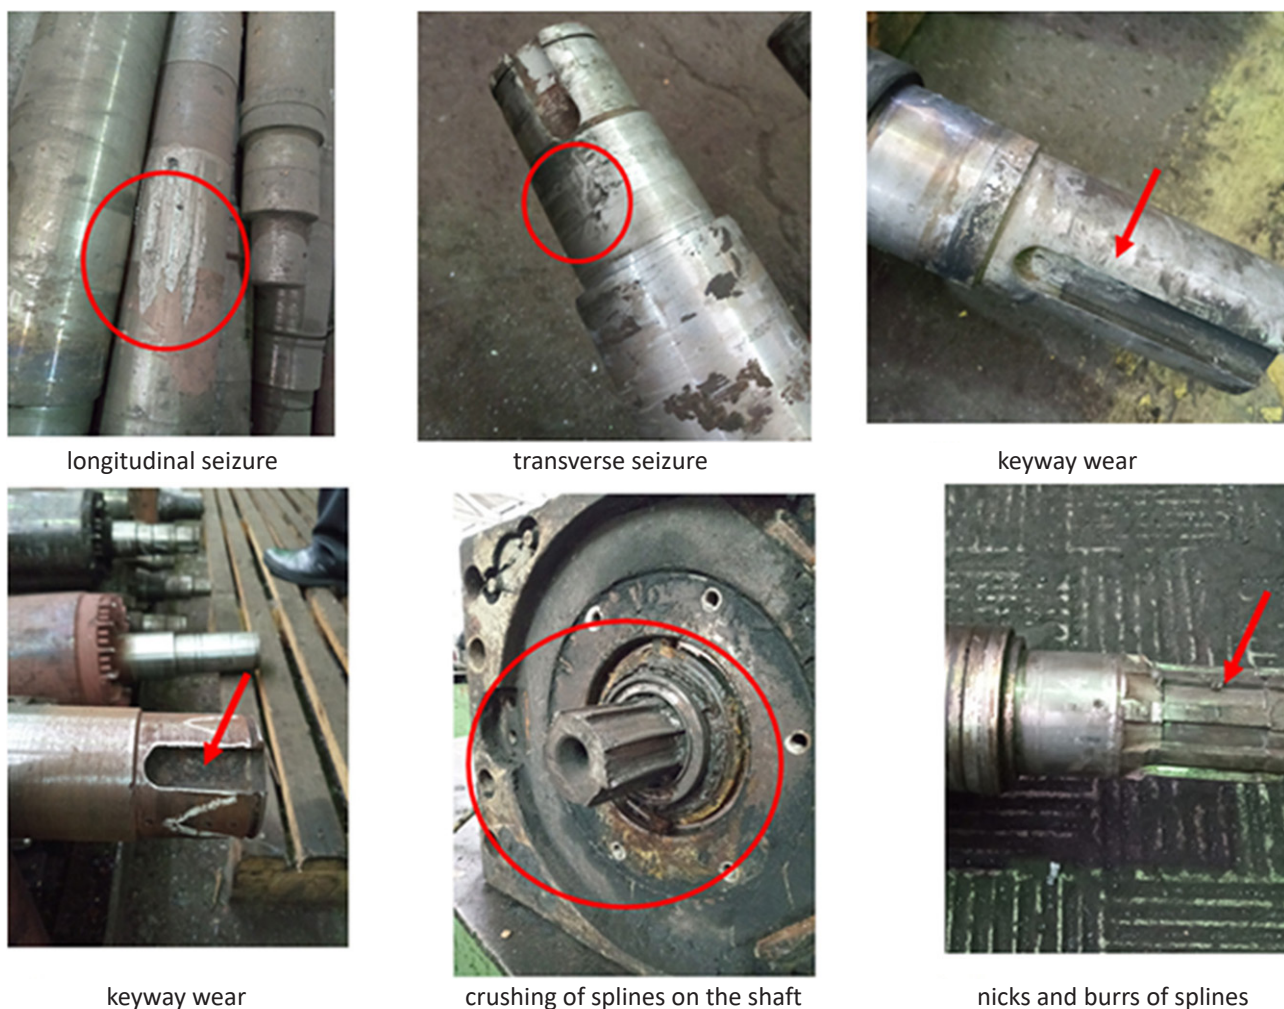
Most of the visited enterprises of the Karaganda region are engaged in the repair and restoration of electric motor shafts. Figure 2 shows the worn surfaces of electric motor shafts.

Figure 2 – Typical defects of electric motor shafts

Worn shaft surfaces are repaired by hardfacing. Its popularity is based on the fact that it allows high-quality hardening of shafts, giving them new shapes, creating an additional layer on the surface with specific mechanical and physical parameters, and restoring the original geometric dimensions of a worn part.

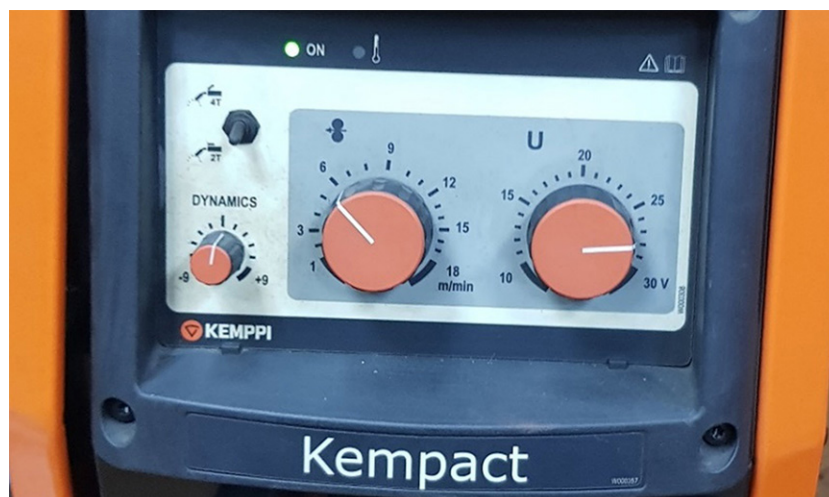
Experimentally, the optimal surfacing modes have been established for the following parameters: voltage 27V and wire feed speed 6 m/min (Figure 5).

Figure 5 – Parameters of surfacing mode

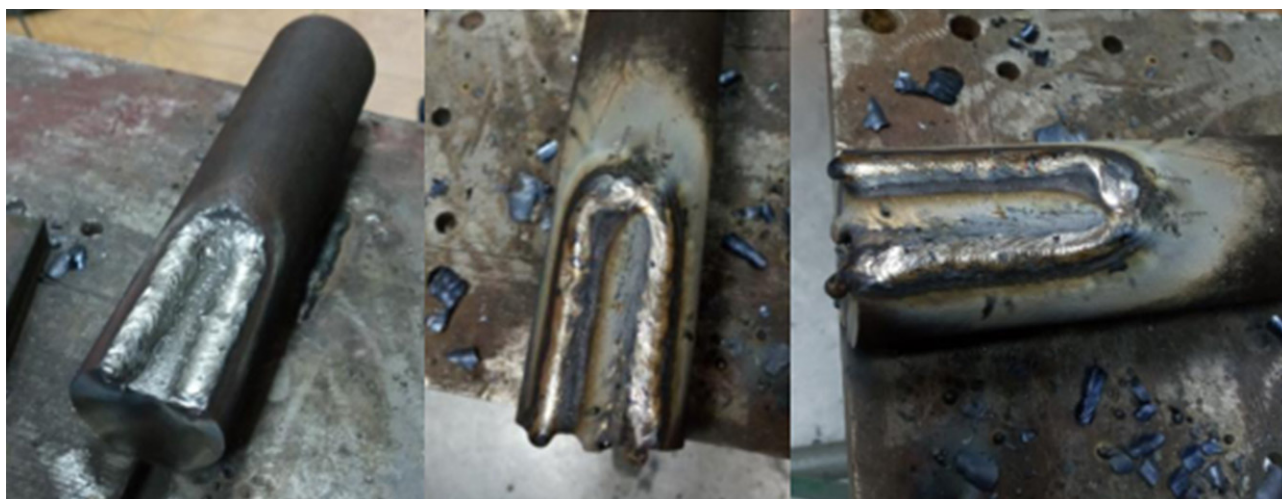
After solidification, a thin slag crust formed on the surface of the deposited bead (Figure 6), while each surface of the previous layer was thoroughly

cleaned from slag.

Figure 6 – Surfaced keyway

The surfacing of the keyway was carried out with additional shielding with CO<sub>2</sub> gas. Surfacing was carried out in multi-layer, beads.

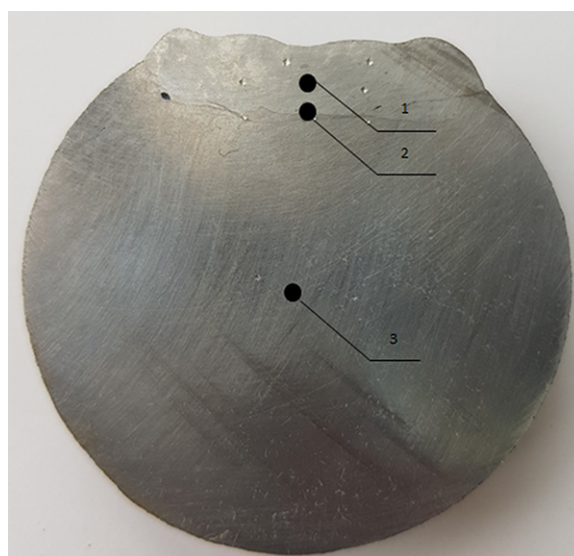
After surfacing, samples were made to determine the hardness of the deposited layer, the hardness in the mixing zone and the hardness of the base metal (Figure 7).

1 – main deposited layer; 2 – fusion zone; 3 – base metal

Figure 7 – Sample for testing hardness

When controlling the hardness of the deposited layer, it was found that the hardness of the deposited layer is 337-372 HV, which subsequently causes difficulties in the subsequent machining of the deposited surface of the keyway.

Sample zones	Deposited layer (2 mm from the fusion zone)	Fusion zone	Base metal (steel 45)
Hardness value, HV	337	372	262
