# Peculiarities of Complex Engineering-geological Surveys on Subsidence Soil

**Abstract.** Paper presents the current problem of road construction on complex soils, the complexity of which lies in their subsidence properties. Insufficient study of soil conditions, in turn, poor preparation of subsidence ground bases during road construction, leads to a decrease in the quality of roads and a reduction in their service life. In order to prevent the consequences caused by these soils, it is necessary to carry out a comprehensive study. The object under consideration (ring road) is located in Almaty, Kazakhstan. According to engineering and geological surveys, the designed site has subsidence. Presented the methodology of field testing of soils, the results of static load tests of the bearing capacity of soil by piles, the results of testing the piles for integrity by the non-destructive vibroacoustic method. These studies are conducted in difficult soil conditions, which provides a high accuracy in determining the characteristics of the soil. The expediency of the selected measures is discussed, taking into account the results of the study and the peculiarities of the construction si

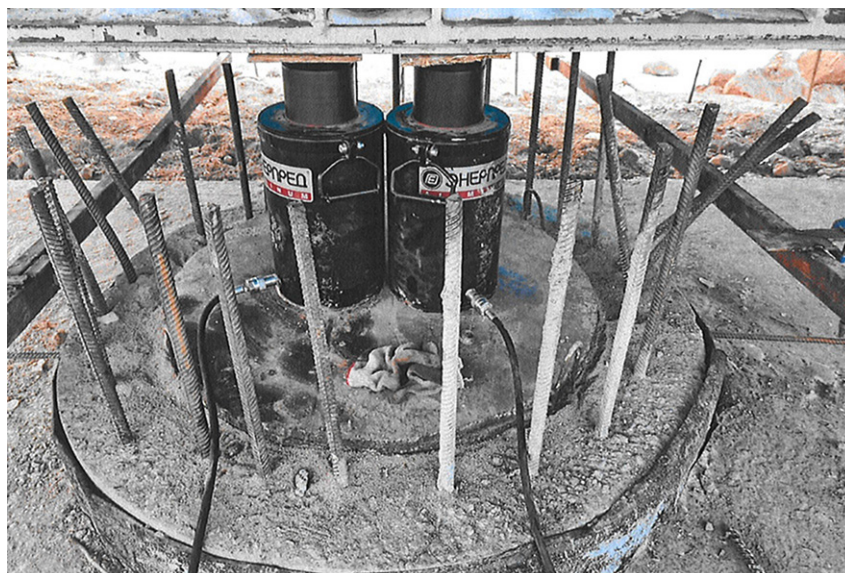
During the tests, to create a load force on the head of the pile being tested load-bearing equipment (power stand made of inventory structures, jack DG200P250, hydraulic pump, high-pressure hose system) and test recording devices (6PAO-0.01 deflectometer, 6PAO-0.1 deflectometer, WIKA manometer) was used. Types of equipment are presented in Figure 3.

Figure 3 – Loading device with hydraulic jacks, girder system with anchored piles

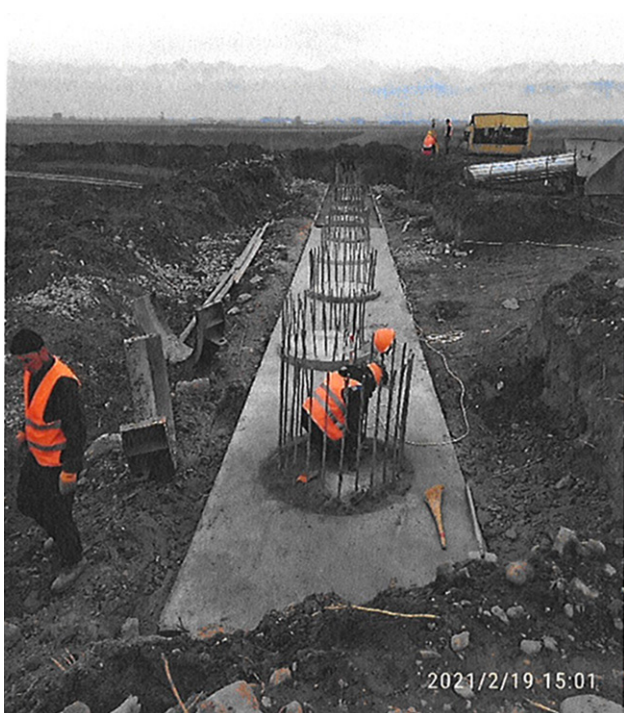
The installation of the sensors was carried out by means of adhesive. The general view of the tested piles is shown in Figure 4.

Figure 4 – General view of the tested piles
